This errata sheet provides updated information about known device issues affecting Arria® II GX devices.

Table 1 lists the specific issues and which Arria II GX devices are affected.

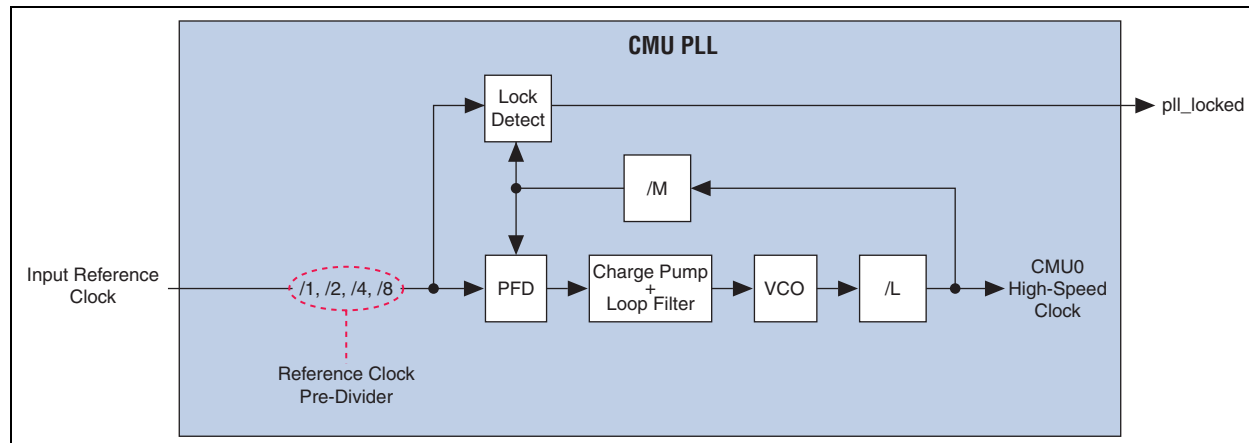
Figure 1. Reference Clock Pre-Dividers in Transmitter PLLs

The transmitter phase-locked loop (PLL) lock status signal (pll_locked) does not de-assert when the pll_powerdown signal is asserted in configurations that use the reference clock pre-divider of 2, 4, or 8. [Figure 1](#) shows the reference clock pre-divider inside transmitter PLLs. This issue impacts the pll_locked status signal in the clock multiplier unit (CMU) PLL.

Designs that implement the recommended transceiver reset sequence described in the *Reset Control and Power Down in Arria II Devices* chapter in volume 2 of the *Arria II Device Handbook* could potentially see a link failure after coming out of reset.

If the pll_locked issue impacts your design, instantiate and connect the pll_locked_soft_logic module, as shown in **Figure 3**. You must use the pll_locked_to_corelogic output from this module in the transceiver reset logic and any user logic that relies on the transmitter PLL lock status signal.
