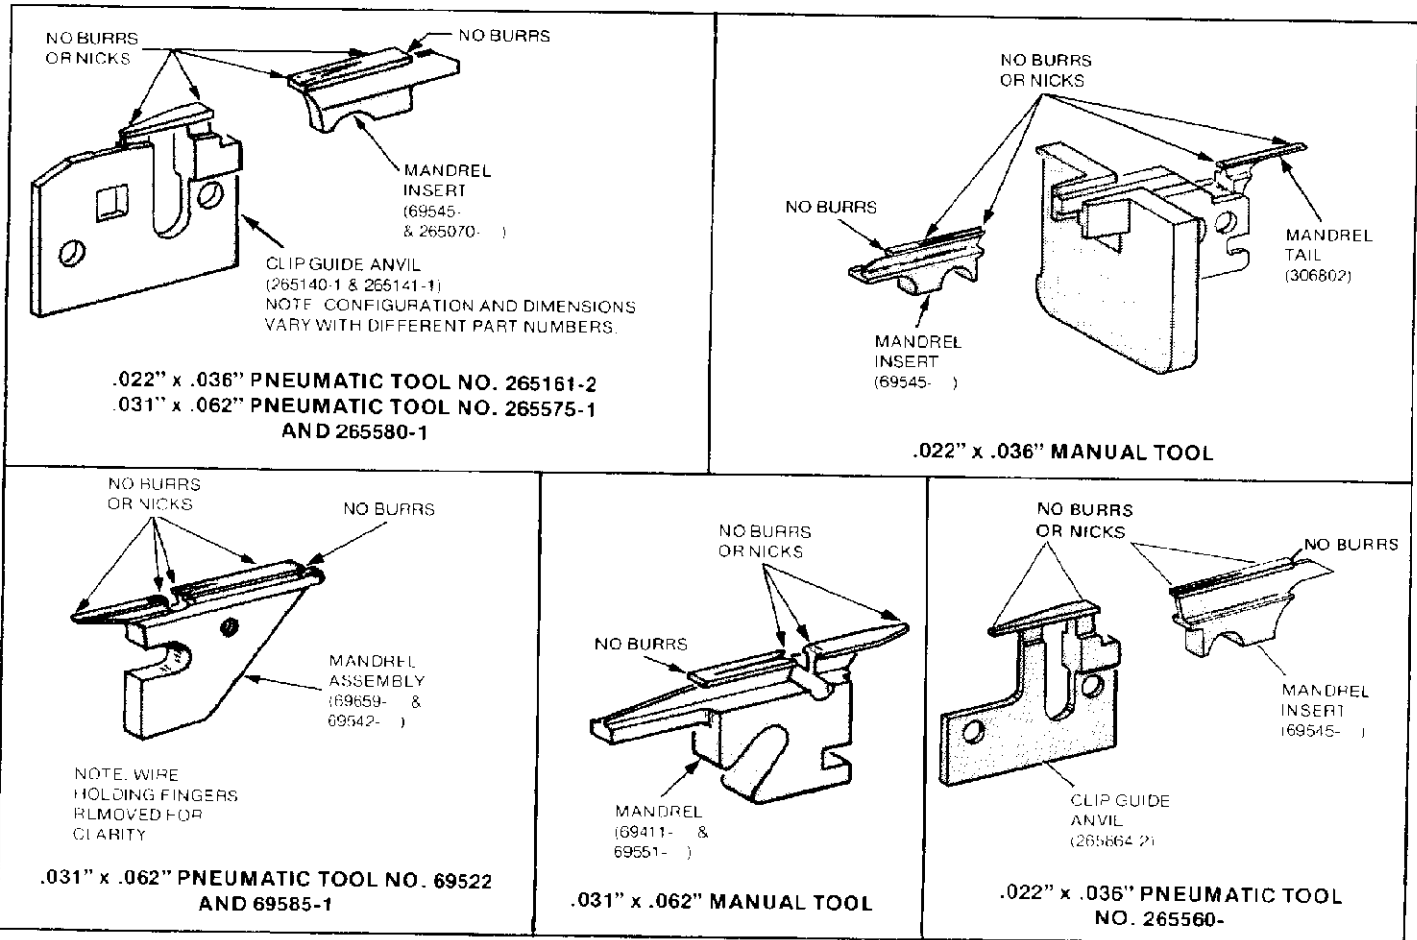
Figure 1 shows the different types of mandrels found in TERMI-POINT hand tools. Nicks and burrs on these mandrels can cause clip jams and damage to other related parts, so they must be stoned off. Some of the causes for nicks and burrs are listed here. They should be avoided.

- Cycling the tool continuously without clips installed.
- Inserting a scribe or sharp object in the stripping groove area to remove stripped insulation.
- Using a scribe or sharp object improperly to remove jammed clips from the mandrel.
- Inserting a scribe or sharp object in the stripping groove area to remove the mandrel from the tool.
- Cycling the tool continuously with clips jammed on mandrel. Note that this can also cause the pushrod to break.

The areas that the clips contact are basically the same on all mandrels. To remove burrs and nicks from the mandrels:

- Remove mandrel and mandrel tail or anvil clip guide from tool. Refer to the Customer Manual for the tool.
- Use a magnifying glass or edge of fingernail to detect the location of nicks or burrs.

- Using a Hard Arkansas Oilstone HF 873 or equivalent, lightly stone the burrs off of the exterior edges.
